MMHE DRY DOCK 3

UNDERWATER INSPECTION REPORT

Utilizing ROV GM ST01

Final Report: ST-SI-MMHE-DD3-01

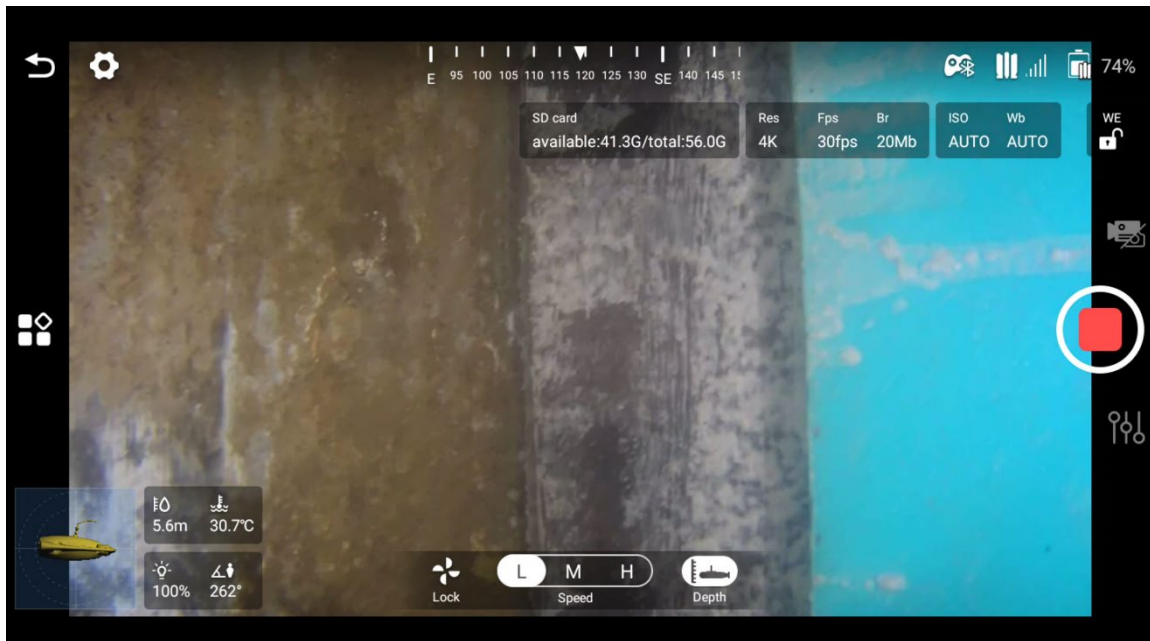
The ROV are equipped with 4K resolution Sony camera. The video footages of the complete operation were saved and reviewed for data analysis. The video yields information and smoothness of recording motion.

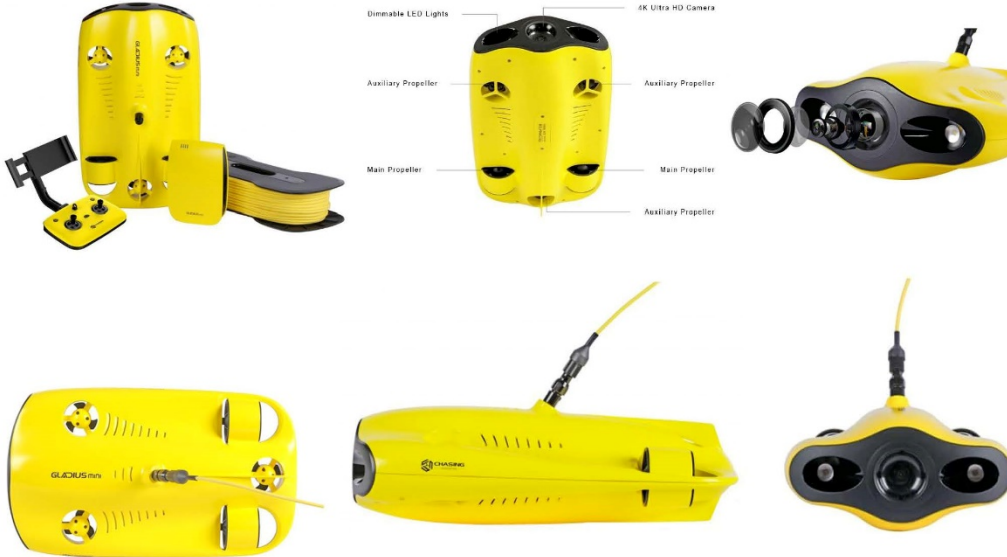
SPECIFICATIONS

ROV	
Size	385x226x138mm
Battery Capacity	55.5Wh (5000mAh)
Weight	<2.5kg
Buoyancy	-10g ~ 10g
Operating Temperature	-10°C ~ 40°C
Maximum Depth	100m
Maximum Speed	>4Kn (2m/s)
Maximum Rise/Fall Speed	2Kn (1m/s)
Maximum Flow Resistance	4Kn (2m/s)
Battery Life	2h (Forward at L speed in a fixed depth mode)
Battery Cycle	>300 times
